## **DAM SAFETY SECTION CRITICAL INFRASTRUCTURE DIVISION**

### **Dam Safety Inspection Report**

DAM: LAKE CHARMAINE DAM

CURRENT INSPECTION DATE: 6/14/2017

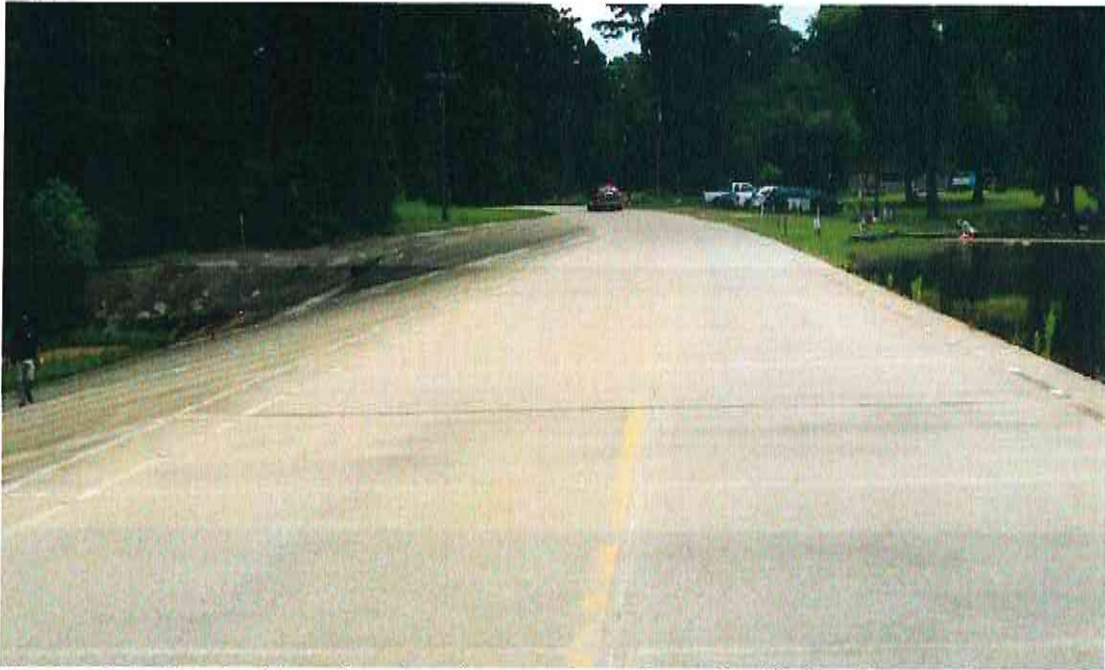
- The dam is 1200 feet long with a crest width (concrete roadway) of approximately 24-ft. The crest was relatively level with no dips or low spots and was found to be in good condition (See Photos 1 and 2).
- Elastic sealant that was noted as missing in some joints from the previous inspection appeared to have been applied everywhere as needed.
- The area of the crest at one of the joints where the 16 cubic yard void was previously detected and was noted to have been filled with flowable fill and

**Photo #1** – Crest of dam (roadway) approximately 24-ft wide looking south.

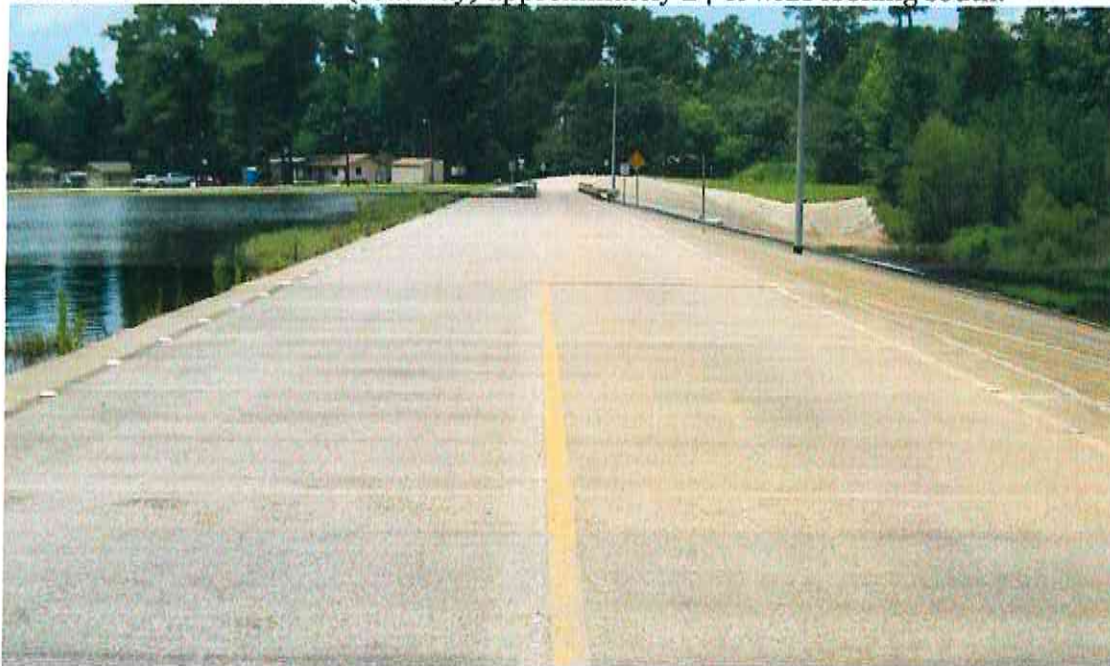
**Photo #2** – Crest of dam near the mid-point of the dam looking north. Crest was level with no dips or low spots.

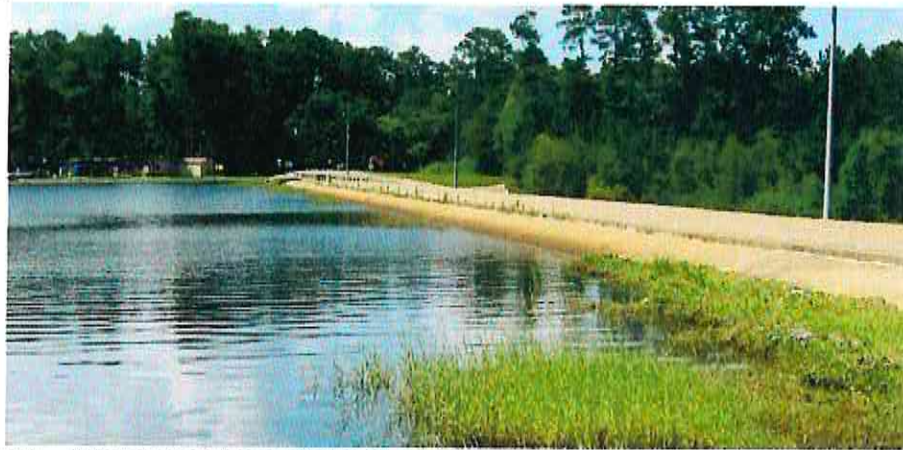
**Photo #3** – Upstream slope of dam looking northeast.

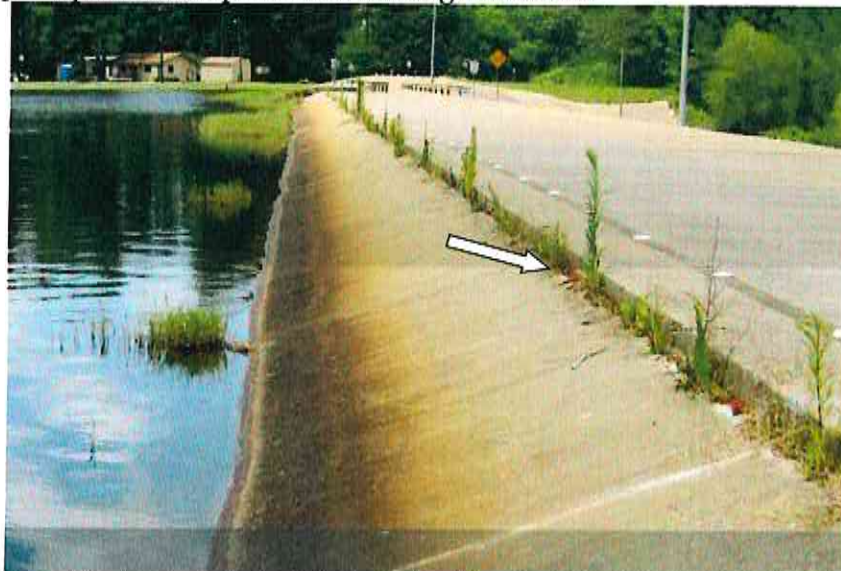
- The upstream slope was capped in concrete slabs with a consistent surface estimated at approximately 3 horizontal to 1 vertical (3H:1V) and was found in good overall condition (See Photos 3-7).
- The previous inspection had noted an open joint between the upstream slope and the crest. That joint was filled with sealant during this inspection. However, small grass was also growing through some of the joint areas.

**Photo #4** – Upstream slope of dam looking north. Note some grass growing through the joint (arrow) at the crest and upstream slope.

- The following are recommendations for addressing the maintenance items noted during the inspection:
  - a) Clear grass growing through open joints and reseal as needed.

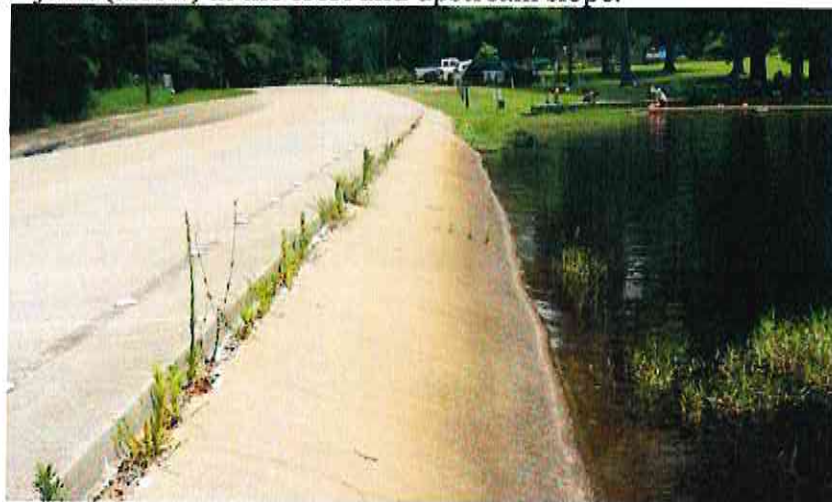
**Photo #5** – Upstream slope of dam looking south.

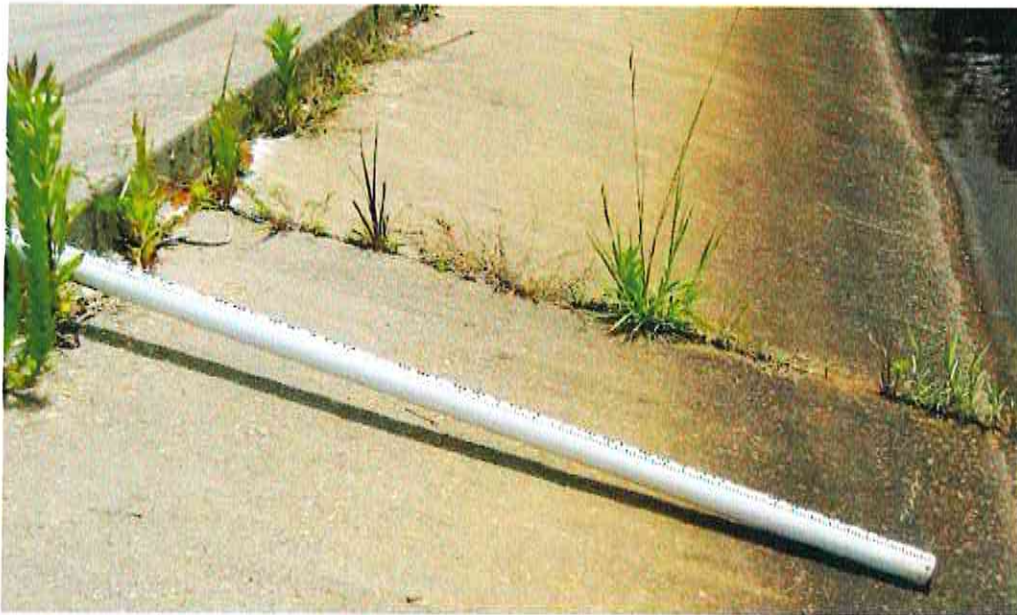
**Photo #6** – Close up view of upstream slope of dam looking south. Note the grass growing through at the joints.

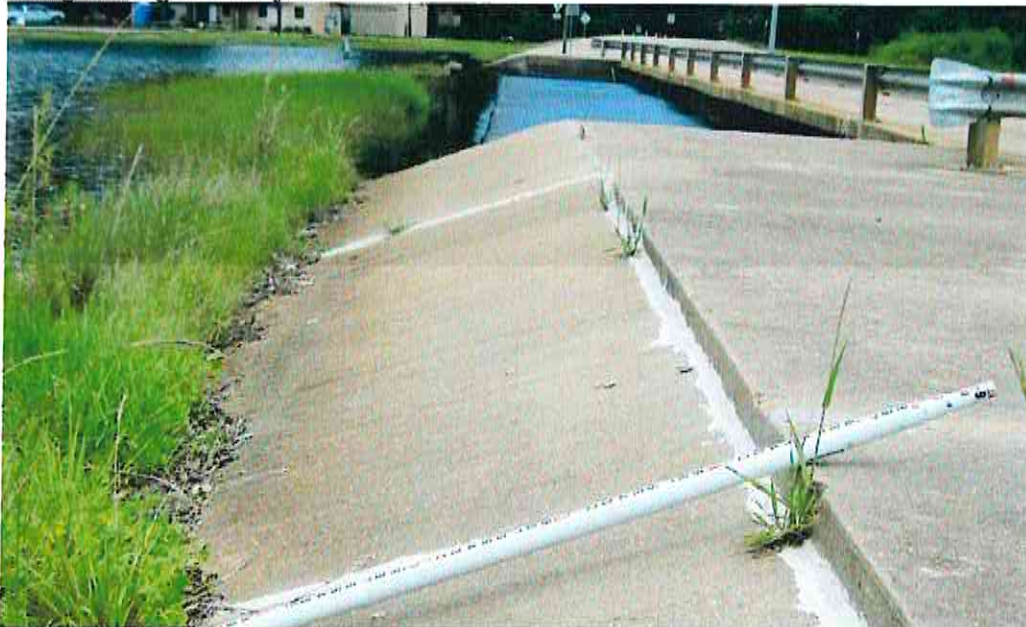
**Photo #7** – Close up view of upstream slope of dam looking north. Note the joint between the crest and upstream slope has had sealant placed since the last inspection.

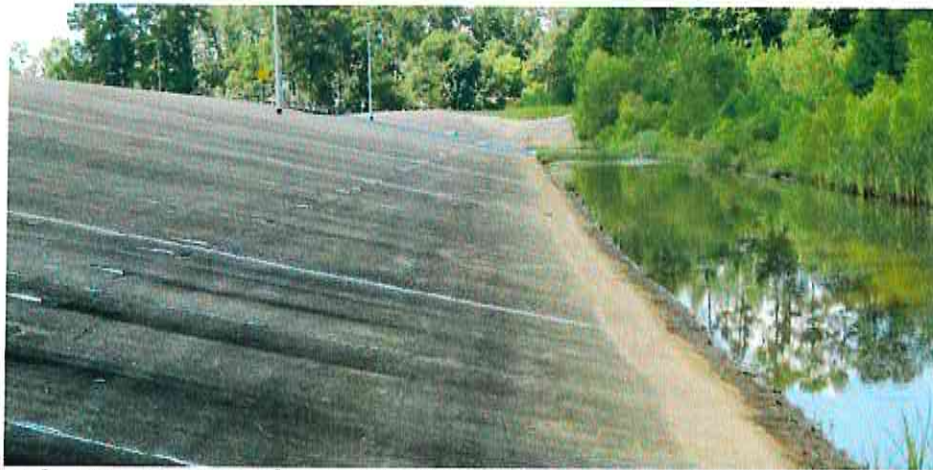
- The downstream slope was capped in concrete slabs with a consistent surface estimated at approximately 3 horizontal to 1 vertical (3H:1V) and was found in poor overall condition (See Photos 8-12).

**Photo #8** – Downstream slope of the dam looking north. Note the consistent slope.

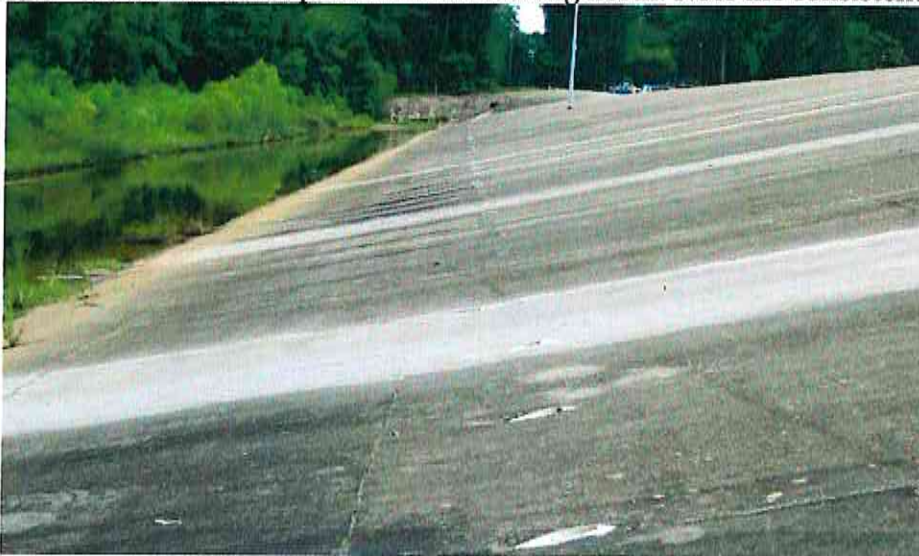
**Photo #9** – Downstream slope of the dam looking south.

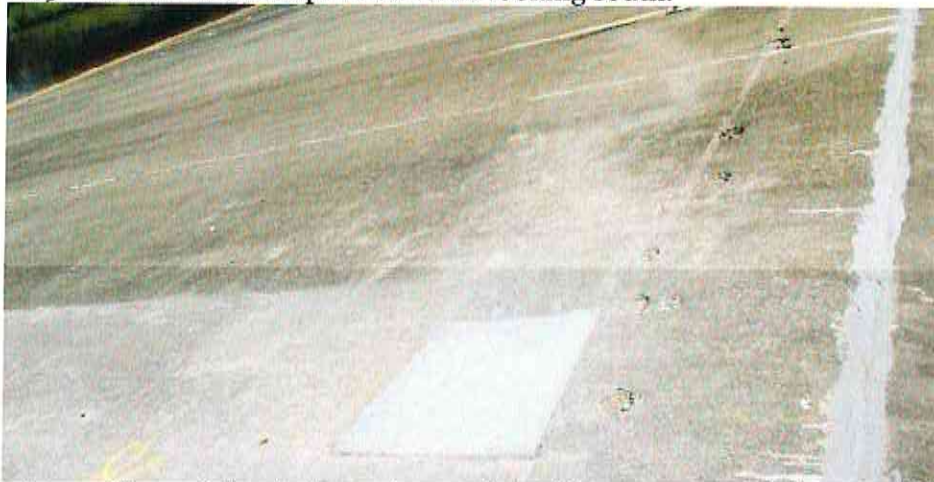
- Some cracking with evidence of seepage emanating from cracks was noted close to the right end of the downstream slope (near the stilling basin).
- Concrete patches, which were noted near the top of the slope closest to the spillway, identified where grout was pumped under the slabs to fill voids.

**Photo #10** – View of dam's downstream slope. The square patch is one of the bore locations where grout was pumped into a void found under the slab.

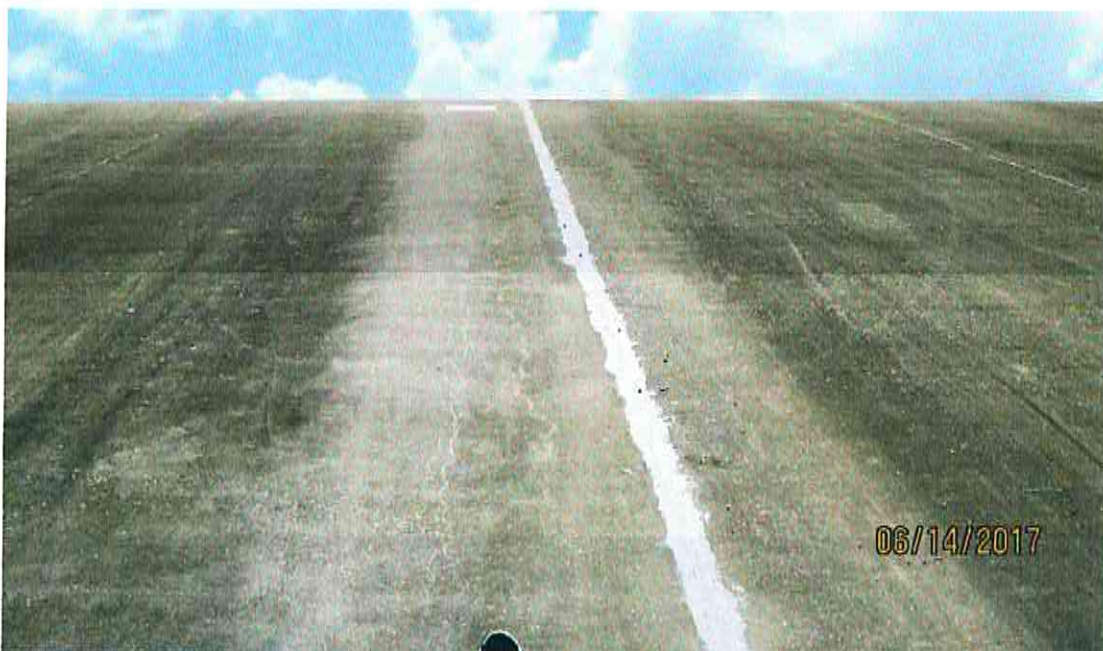
- Sealant (which appeared relatively recent) was noted at all joints that in past inspections showed several large gaps.
- Weep holes at the base of the slope appeared to be clear of debris and sediment. The previous inspection noted that many of these were clogged. However, it was unclear if they were effective as no evidence of drainage was observed and seepage appeared from nearby cracks.

**Photo #11** – View of dam's downstream slope near mid-point of dam looking west. Note the sealant at the joint in effort to prevent seepage under the slab. Additionally, the weepholes were found to be cleared of debris.

- f) Monitor steel cable grates for damage, and repair if grates fail or become unserviceable due to damage from debris.
  - g) Monitor weep holes for evidence of drainage to determine if they are effective in relieving pressure from behind the concrete slabs.

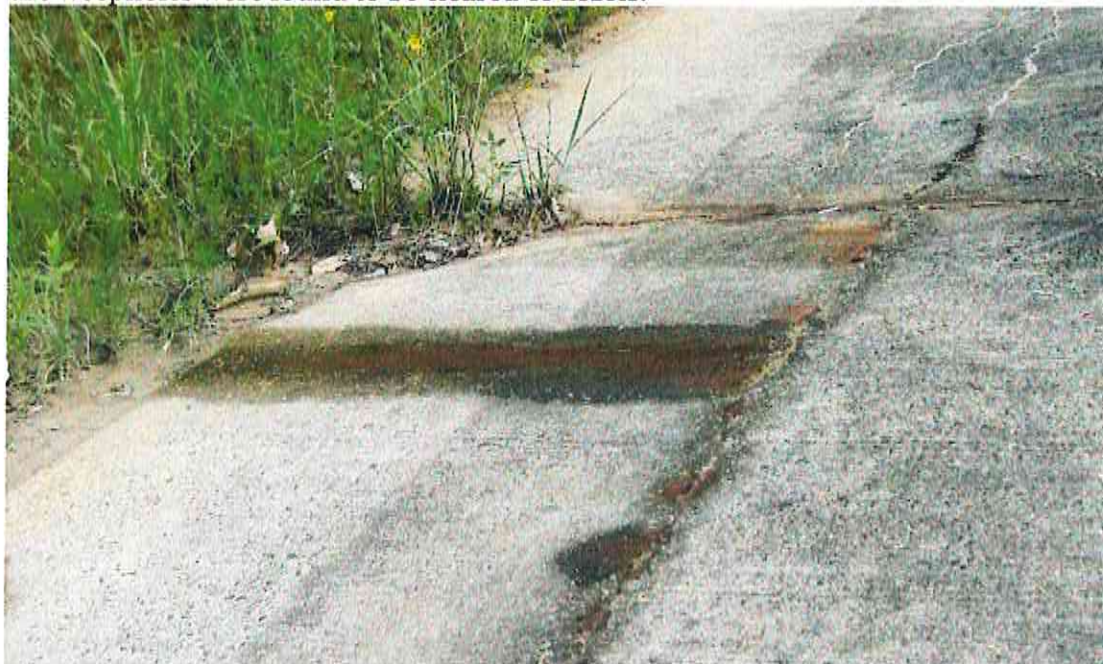
**Photo #12** – View of dam's downstream slope near the right end of dam looking southeast. Some seepage appeared to be occurring at this crack in the concrete slab. Areas of seepage in the slab were also noted in the previous inspection.

- e) Monitor areas of seepage along the downstream concrete slabs and at the low-flow outlet. A log of seepage location and flow rates along with the lake level and date should be recorded and maintained.

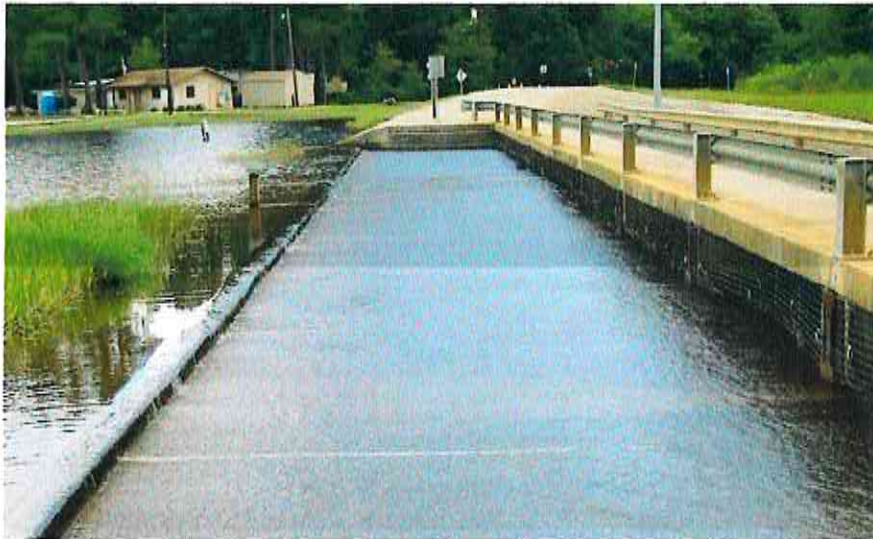
**Photo #13** – View of the dam's service spillway looking north. Note the spillway was engaged approximately 2-inches during the inspection.

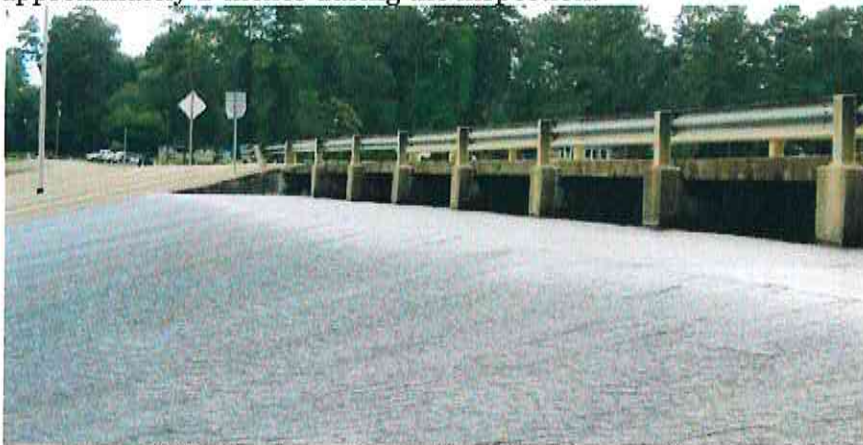
**Photo #14** – View of the dam's service spillway looking southwest.

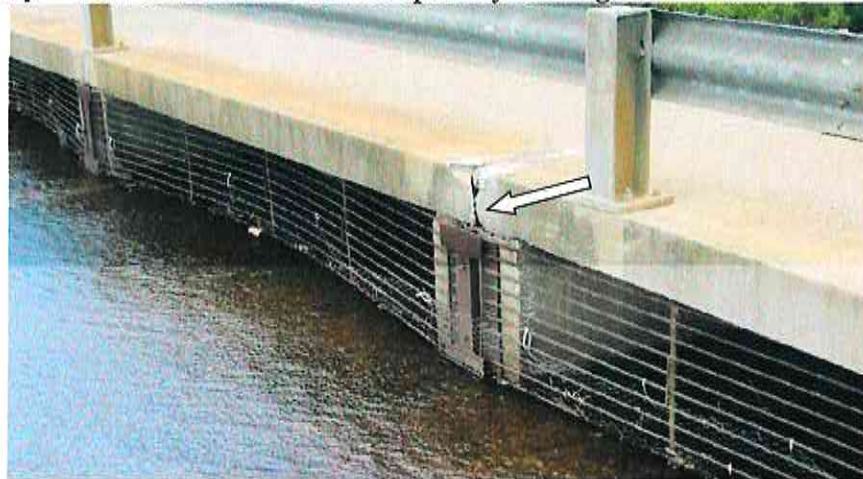
**Photo #15** – View of the dam's service spillway looking northeast. Note the wire grate at the spillway bridge. Also, some cracking (arrow) was observed at the bridge

- c) Heavy vegetation growing around the stilling basin area should be removed.
  - d) Repair spalling, and seal minor cracks throughout the concrete slabs, particularly around the bridge and service spillway area.

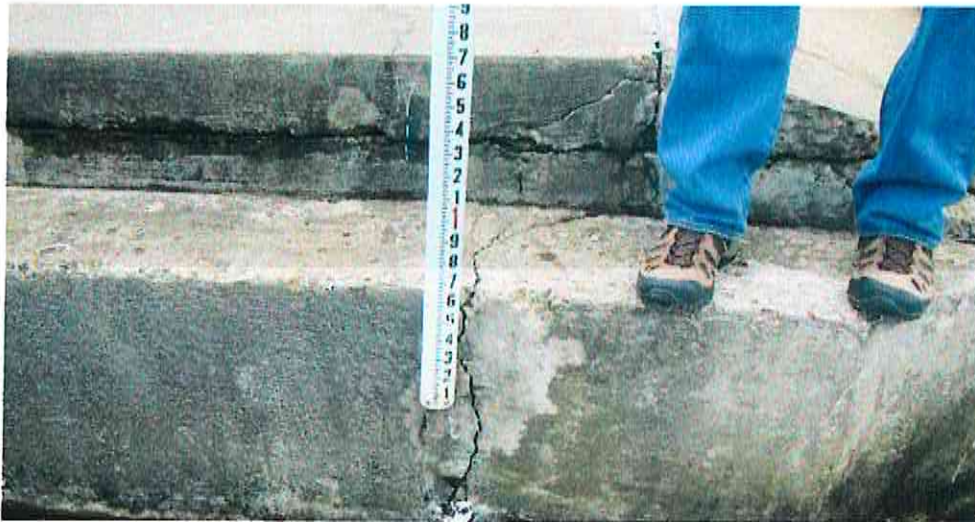
**Photo #16** – View of cracking occurring in the concrete slab along the entrance to the spillway looking south.

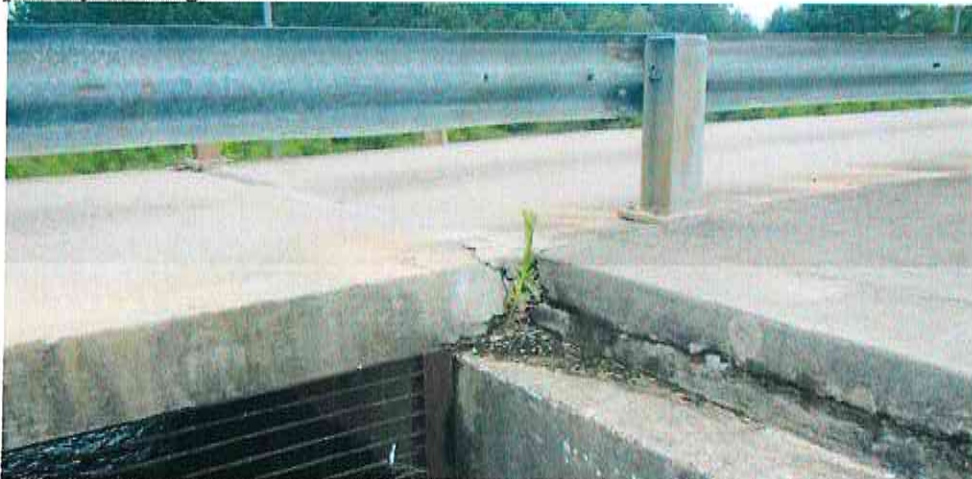
**Photo #17** – View of cracking along the bridge at the spillway looking southeast.

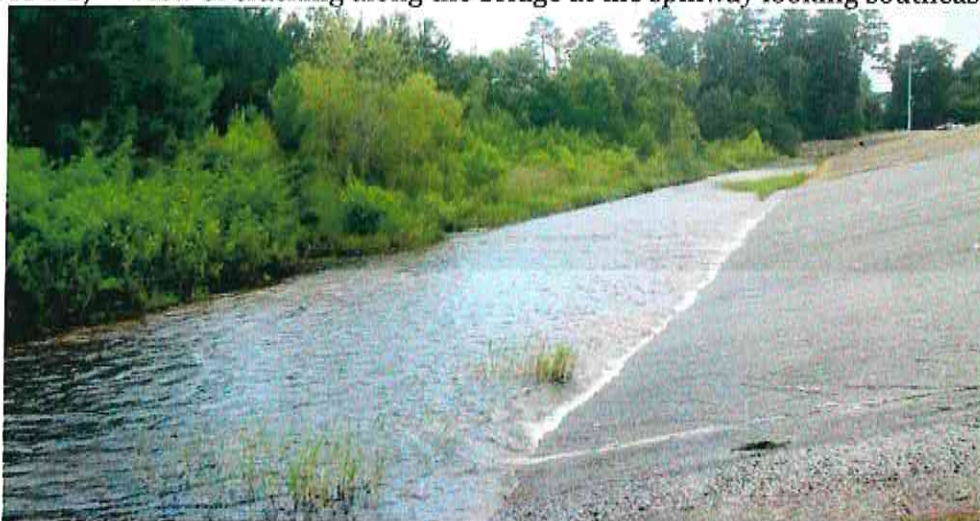
**Photo #18** – View of the service spillway outlet and stilling basin looking southeast.

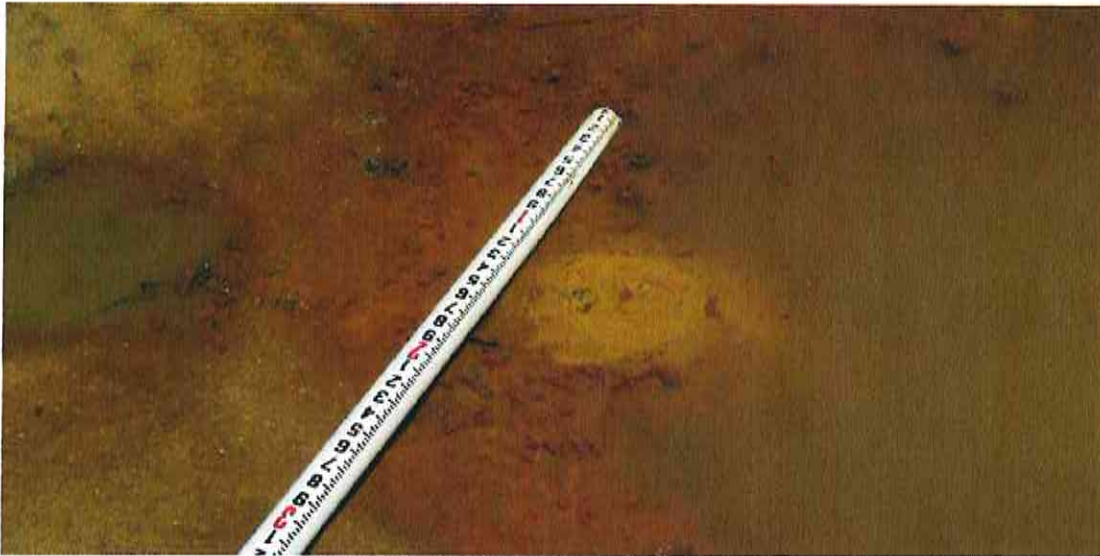
- At least one boil was identified in the same general location of the stilling basin as had been noted in past inspections. Mr. Harrison stated that there were now less boils than before the grouting project was completed.
- Heavy unwanted vegetation was noted to be growing around the stilling basin area.

Due to the potential piping condition occurring at the toe of the downstream slope of the dam, a significant storm event could raise the water level and head

pressure to accelerate any piping and cause a washout of the embankment material to such a degree that the concrete slabs could separate or fail and allow an uncontrolled loss of the reservoir.

**Photo #19** – View of bubbling occurring at a boil located in sediment at the stilling basin just downstream of the concrete slope. Boils, which were noted during the last inspection, were also observed during this inspection. However, there did not appear to be as many or as large as noted in the previous inspection.

- The persistent problem with sand boils and sediment accumulation requires a licensed Texas Professional Engineer with dam experience to diagnose the problem and develop a long-term solution. The development of any plans requires submission and approval through Dam Safety prior to commencement of any construction improvements.

- b) Remove silt from the stilling basin area and monitor the inflow of new silt and quantity and condition of boils as they re-appear. Locations of the boils should be recorded with dates and quantity of sediment removal.

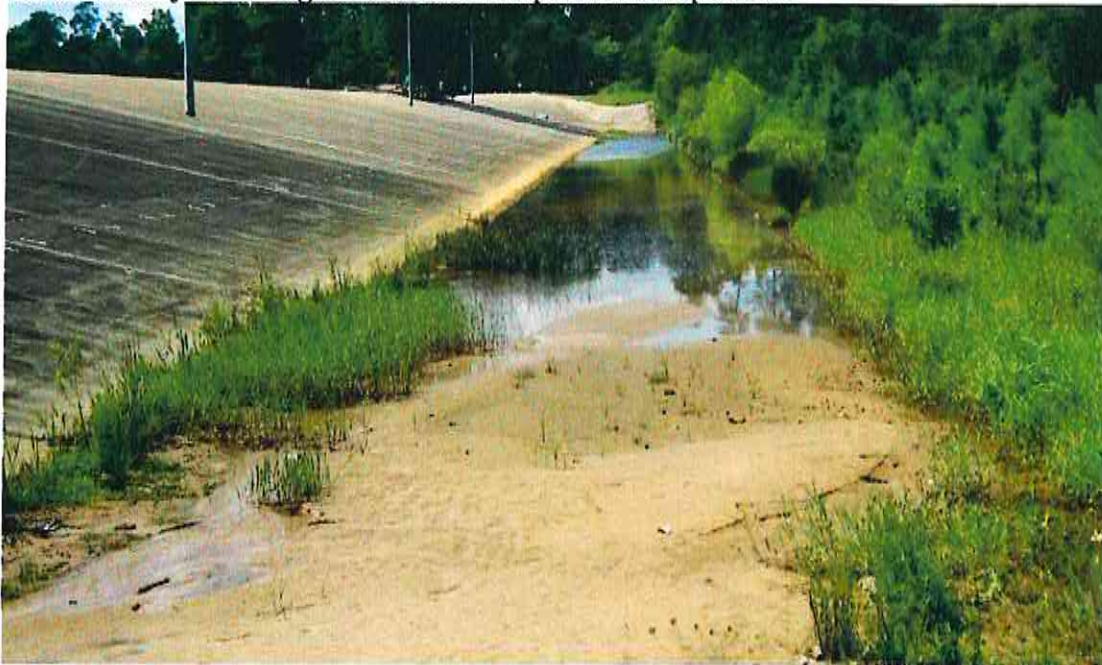
**Photo #20** – View of sediment buildup and grass in the stilling basin area looking north.

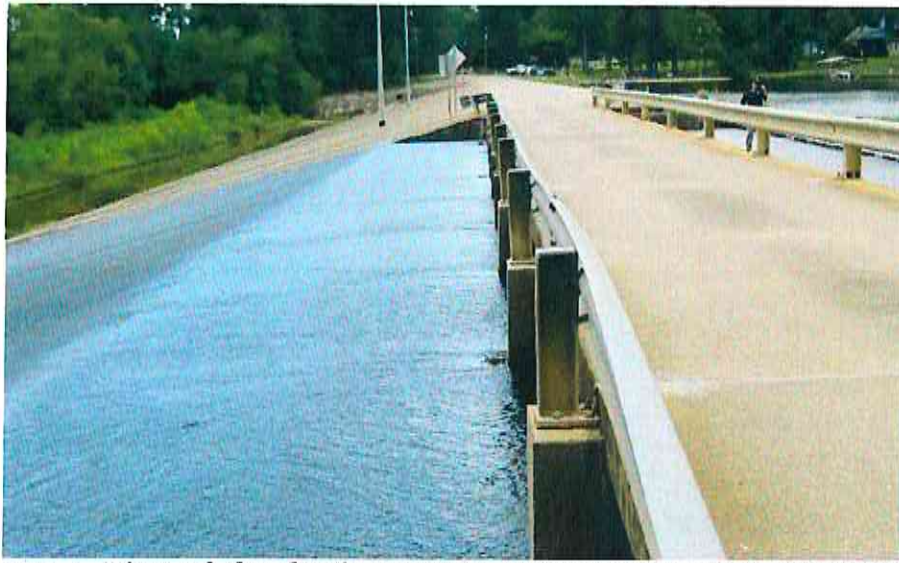
- The concrete capped portion of the embankment is capable of handling flows over the crest and roadway and therefore functions as an emergency spillway at up to 900-ft long. The overall structure was found in fair condition (See Photos 20 and 21).
- The spillway portion of the roadway is estimated to be about 3 feet below the abutments (not protected with concrete) on each end.

**Photo #21** – View of the dam’s concrete embankment which functions as the emergency spillway during an extreme storm event.

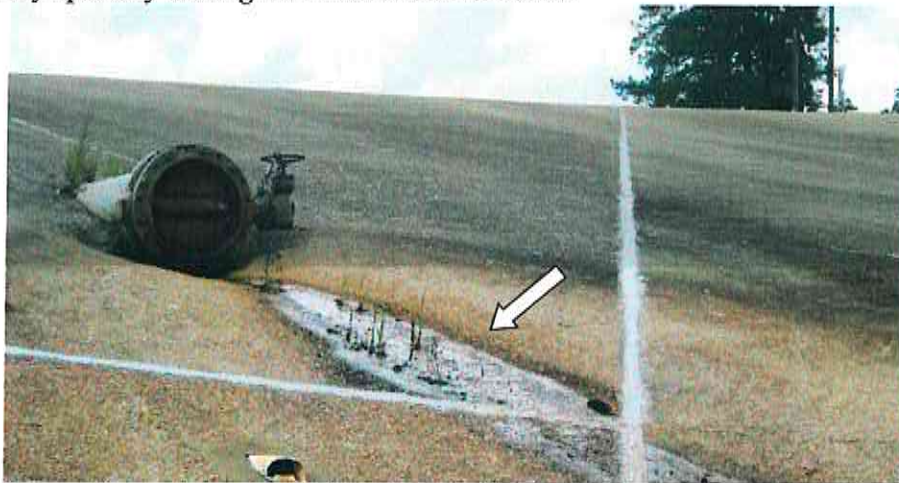
- The low-flow inlet/outlet is located on the left end of the dam (marked by a warning sign) and consists of 24-in. steel pipe and valve at the downstream end. Mr. Harrison stated that the pipe and valve is used regularly (See Photos 22 and 23).
- Evidence of potential seepage at the low-flow outlet was noted during this inspection. This appeared to be similar to what was noted in the prior inspection. Overall the outlet appeared to be in working condition.

**Photo #22** – View of the dam’s low-flow outlet (24-inch outlet and valve) at the north end of the embankment looking northwest. Note some evidence of seepage below the outlet as also noted in previous inspection.

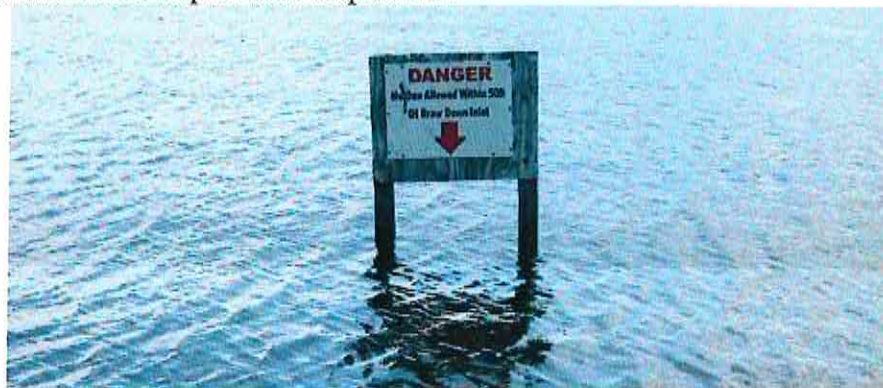
**Photo #23** – View of warning sign where the low flow inlet is located just next to the left side of the embankment looking west.
